I was part of a post-disaster investigation in March, about 2 weeks after the main shock. The team that I was with had a geology emphasis.

This briefing draws upon the work of the geologic and tsunami investigations performed by my fellow members of the Geoengineering Extreme Event Reconnaissance team which went to Chile in early March 2010. Our work is now published on the GEER website – [geerassociation.org](http://geerassociation.org). It also draws upon the material developed by members of the Learning from Earthquakes program of the Earthquake Engineering Research Institute, also sponsored by the National Science Foundation, the Pacific Earthquake Engineering research center, and the U.S. Geological Survey. A team of lifeline experts went to Chile later in March and their insights are also posted at the EERI clearinghouse, [www.eeri.org](http://www.eeri.org), as the TCLEE report .

## M<sub>w</sub>8.8 earthquake struck at 3:34 am, Saturday, February 27

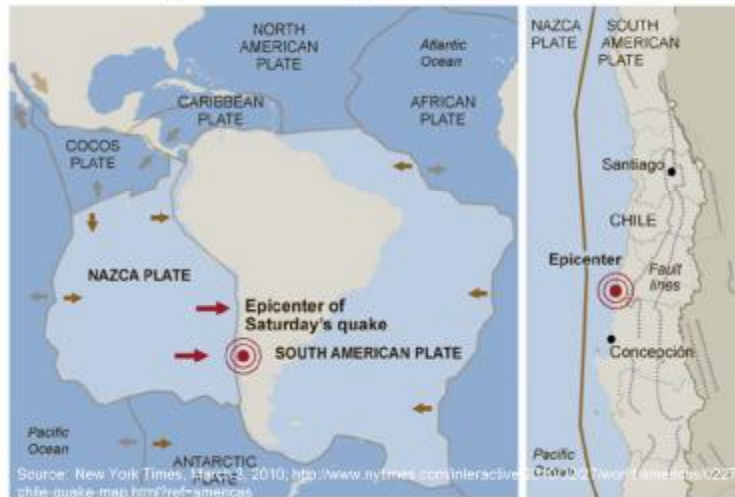
The M<sub>w</sub>8.8 earthquake struck off the coast of central Chile at 3:34 am on the morning of Saturday, February 27, 2010. The epicenter was about 205 miles (330 kilometers) southwest of the nation's capital, Santiago. This was a great earthquake - the 5th largest earthquake ever recorded. It occurred on a tectonic plate boundary, where the Nazca Plate is being subducted underneath the South American plate. This subduction is the source of energy creating the Andes mountain range that divides Chile and Argentina.

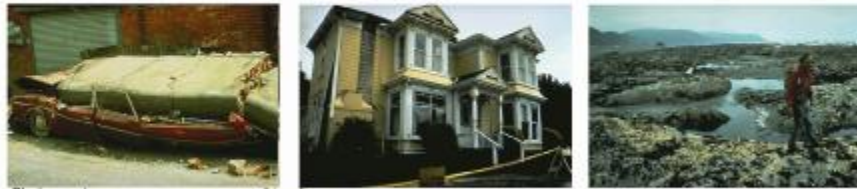
- Main shock: M7.2, April 25, 1992, 11:06 am, near small town of Petrolia, Humboldt County, California
- 2 Aftershocks: M6.5 and M6.7, morning of April 26
- 25 km of uplift (1 meter max) along coast
- Tsunami (1 foot max height) recorded along West Coast and Hawaii; reached near-field coast (1 min), Humboldt Bay (20 min), and Crescent City (50 min)

A similar but smaller earthquake of M7.2 struck on April 25, 1992, at 11:06 am, at the boundary between the Cascadia and San Andreas systems in the Cape Mendocino area of northern California. Two additional shocks of magnitudes 6.5 and 6.7 occurred the next morning. The main shock generated uplift of up to 1 meter along a 25 km section of the coast and caused a tsunami that reached the mouth of Humboldt Bay in about 20 minutes after the shaking with wave heights of about 1 foot. It reached communities closer to the Cape in even less time. The tsunami arrived at Crescent City in 50 minutes and was detected in Oregon, the San Francisco Bay Area, Santa Barbara, and Hawaii. Although not destructive, the earthquake is a good indication of the kinds of effects we would likely see, but at a much more destructive scale, in a M9 Cascadia event.

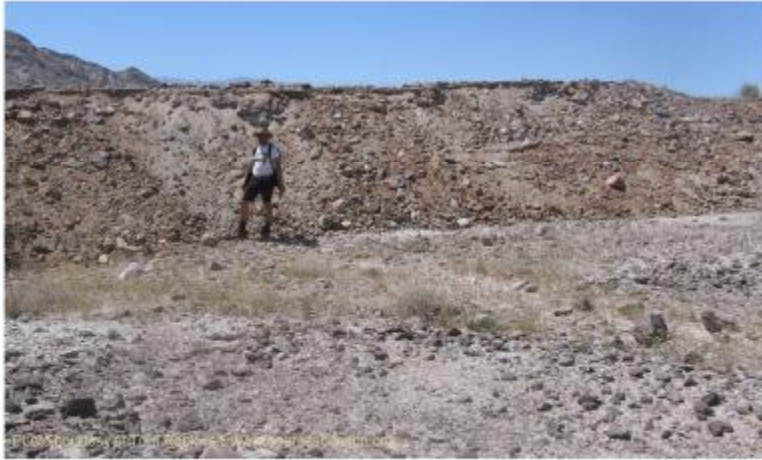
## M7.2 Baja California (April 4, 2010)

The section of the plate boundary system just to the south was the source for the recent M7.2 earthquake that struck on Easter Sunday. This photo is of the rupture along the Borrego fault – the main source – which has exhibited about 3 meters of both horizontal (right lateral) and vertical slip. The rupture set off a major aftershock sequence that has extended north onto the San Andreas system, and rattled southern California for the past couple of weeks.

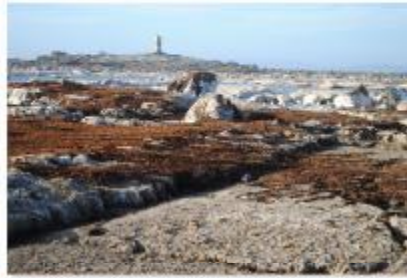
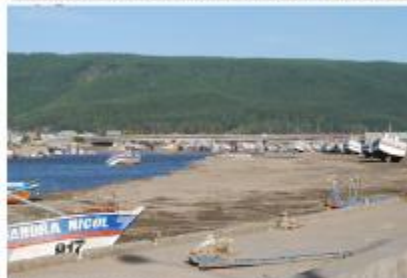
## Tectonic uplift >2 meters in Lebu

Part of my research focused on understanding the permanent deformation that is likely to result to the land, as well as impacts to buildings and infrastructure, as a result of these movements. One of the most dramatic illustrations of the permanent effects was in Lebu, on the south end of the rupture zone which saw uplift greater than 2 meters. Lebu's harbor has been severely impacted as illustrated in these photos – with the former lighthouse island becoming a peninsula and boats being stranded. The impacts to subsurface systems were also significant and still being evaluated by other experts.

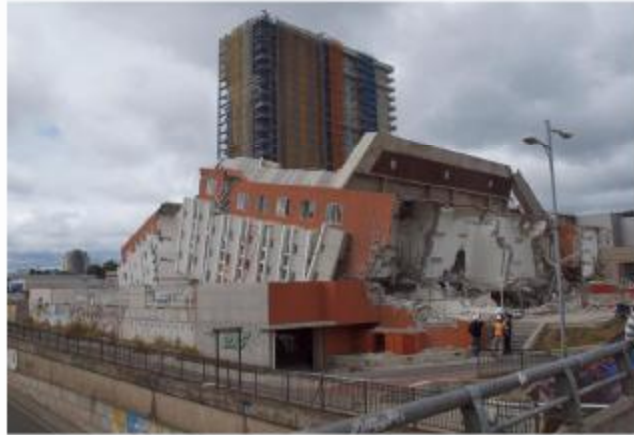
Rio Alto apartment building, Concepcion; Photo courtesy of Jack Moehle, [www.peer.berkeley.edu](http://www.peer.berkeley.edu)

While nearly all of them performed very, very well, even when subjected to the maximum design levels of shaking, a few did not. This building was in the news and the site of a major search and rescue operation for several days. You are looking at a view of the entrance to the building's underground parking garage on the left, and the building has toppled over onto its back with the base shown here in the upright position. A major commission has been appointed to investigate the cause of this buildings collapse,...

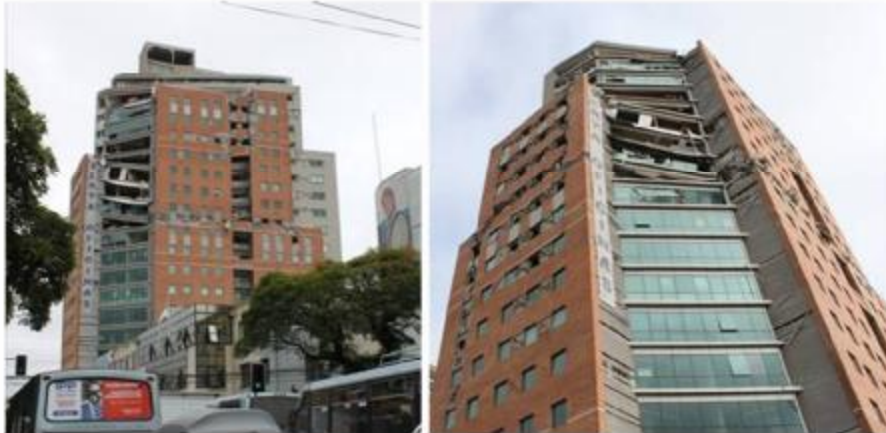
Apartment building, Concepcion; Photo courtesy of Jack Moehle, [www.peer.berkeley.edu](http://www.peer.berkeley.edu)

But already national and international engineering experts are raising questions about the design, construction quality, and code enforcement practices, particularly in recent years. Here is another reinforced concrete building that sustained substantial damage to the upper floors.

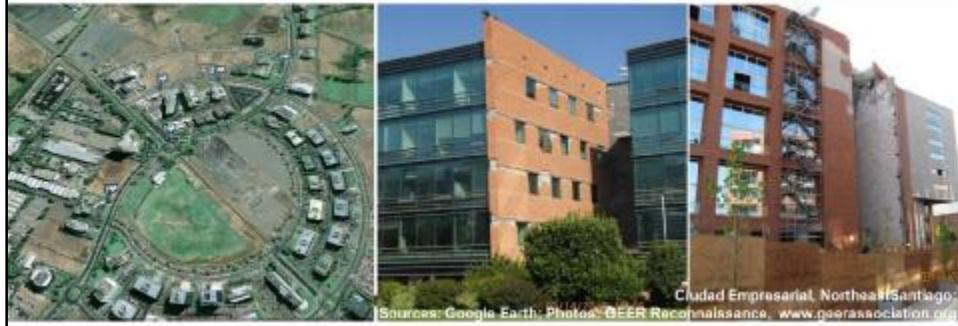
## Some structures on soft or poorly compacted soils had extensive damage

- Included modern, engineered structures in Santiago, central valley, and along coast
- Areas with higher water tables and near waterways—rivers, lakes, lagoons, bays, and beaches, most susceptible

Another major issue that we also saw in the Nisqually earthquake and in California in Loma Prieta and Northridge are the contribution to damage that soft or poorly compacted soils can make. Engineered structures in deep alluvial basins around Santiago, in the floodplains of towns located along rivers in the central valley, or in areas of higher water tables along the coast and waterways were all impacted by these vulnerable soil types. These images are from a business park in northeast Santiago; several well built buildings suffered extensive damage that was likely caused by the amplified ground motions that happened at this site.

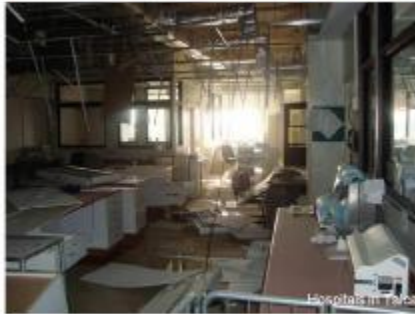
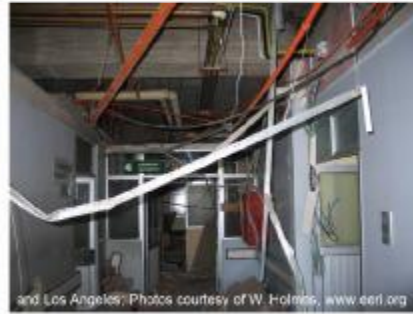
Hospitals in Chile and Los Angeles; Photos courtesy of W. Holmes, www.eeri.org  
Laurie Johnson PhD AICP

- Nonstructural systems very comparable to U.S. – nonstructural walls, ceiling tiles, M/E/P equipment and distribution systems
- Code-specified nonstructural protection not enforced

While there are many, many more engineering lessons, I want to focus briefly on the issue of non-structural losses which were quite significant even in structurally sound buildings. Nonstructural systems in Chile are quite comparable to the U.S. – in fact they call the ceiling tile systems, California ceilings,. These images are from two hospitals that were closed because of non-structural damage. Damage to ceilings, nonstructural walls, mechanical, electrical and plumbing equipment and distributions systems were all quite significant and are leading to major delays in business resumption. Even those Chile has code-specifics for nonstructural protection, it is not well enforced – also a problem we have in many places in the U.S.

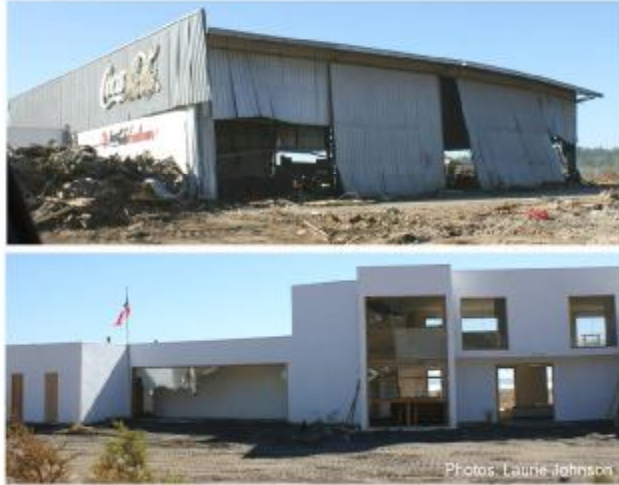
Distinguishing cause of loss:  
Shaking or tsunami? Similar to wind vs.  
surge

Another major issue that we need to think about is distinguishing the cause of loss. These images of modern buildings that were both shaken and then impacted by the tsunami, look eerily familiar to buildings impacted by both wind and surge. It is difficult to know how much of the damage was actually shaking related when the structure has been washed away.

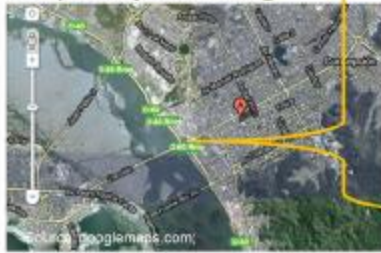
## Road and bridge damage impacted response and regional transportation

- Critical issues of redundancy in central valley (Route 5) and Bio Bio River, Concepcion
- In Concepcion, only 1 of 3 bridges operational with a temporary crossing

As I mentioned at the start, all the lifeline systems suffered damage and much of it was already being repaired when we were there 2 weeks after the earthquake. Certainly subsurface damage will take much longer to find and fix, and more detailed studies will be coming out in the next few months. I'd like to address one issue briefly and that is damage to roads and highway bridges. Damage to these systems impacted the country's response efforts and is still having a major impact on the region's recovery as trucks have to navigate the reroutings on the country's major artery through the central valley – route 5 – and over the mountain highways to the coastal ports. In Concepcion, only 1 of the 3 highway bridges over the Bio Bio was operational. I showed a previous image of one of the most heavily damaged and collapsed Bio Bio bridge. The John Paul the 2<sup>nd</sup> at the far north was also destroyed. In mid-March only the middle bridge – the Llacolen – was in operation. While the bridge itself was in good shape, all the approach ramps had been damaged. Temporary steel structures were being installed. Traffic delays was quite substantial.

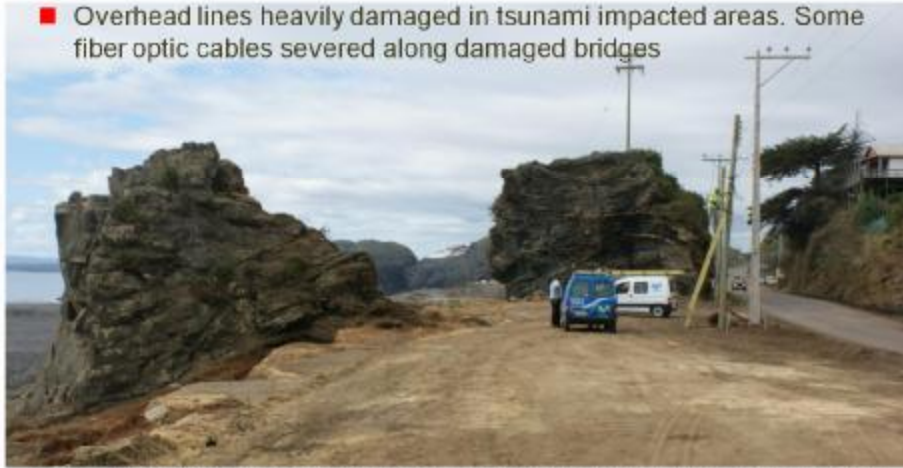
Source: Modified ASCE TCLEE Chile web report, May 2010; [www.beri.org](http://www.beri.org); Photo: Telecom restoration in Peihuhue, Laurie Johnson

- Overhead lines heavily damaged in tsunami impacted areas. Some fiber optic cables severed along damaged bridges

All service providers, both landline and wireless services, experienced extensive setbacks due to commercial power outages, equipment failures, building failures, and loss of reserve power in most distributed network facilities (base stations, small remote switches, and digital loop carrier (DLC) remote terminals).

Another example of damage is that a backup generator failed due to a transfer switch problem, which was used to power the air conditioner. This caused overheating of electronic components that resulted in equipment malfunction.

About 70 % to 80 % of the cell sites in regions VII and VIII had problems with either equipment or antenna damage. This rate falls to about 50 % in region V, mostly in sites located in rooftops. Cell sites do not typically anchor equipment. Switches and MTSOs have seismic designed equipment.

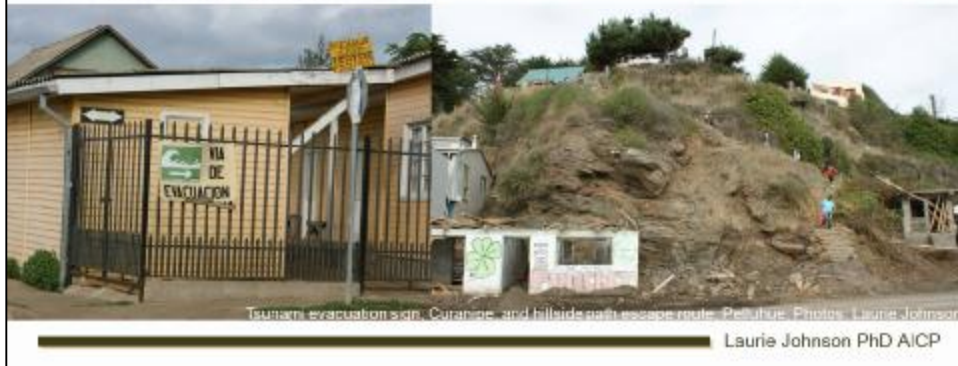
- Residents knew what to do and ran to hills
- Tsunami response plans and warning systems were inadequate, with incorrect signals and poor communications

The first has to do with casualties. Although all the forensic data wasn't available to us, media and local reports indicated that most the earthquake related deaths were caused by the tsunami. And many were tourists. It was late summer in Chile and a peak weekend for tourist travel to the coast. This was particularly problematic since the earthquake struck just after 3:30 am, and power was immediately knocked out in many places. Many people we spoke with recalled how bright the moonlight was, how many people were still partying in crowded discos and other tourist facilities at the beaches, how warning systems did not work, how locals knew that a tsunami was likely after an earthquake and ran for higher ground as soon as the shaking stopped, but tourists did not. Now, looking back, there is much blame being laid with local governments who had not used the tsunami inundation maps that had been developed by the Chilean navy in the past few years, how high occupancy, tourist and camping facilities were located in the inundation areas, the national and local warning systems and signage were inadequate, and that there was a major breakdown in emergency communications at all levels of government.

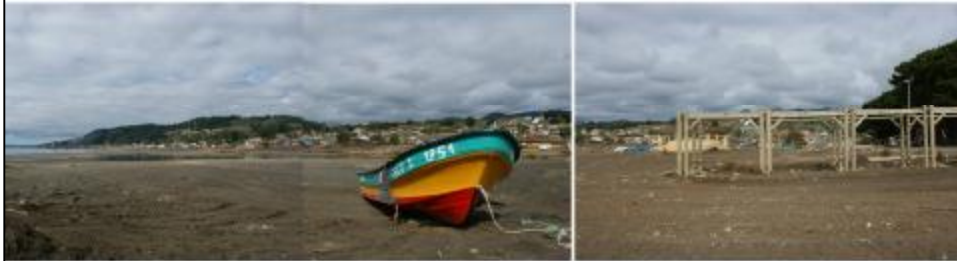
Tsunami impacted beach and campground facilities, Curanipe. Photos: Laurie Johnson

The town of Curanipe is a very popular beach resort just north of the earthquake's epicenter and therefore was struck by the tsunami in less than 30 minutes after the shaking.

A campground, restaurants, hotels, discos, outdoor amphitheatre and other facilities were all located in the low-lying area along the beach.

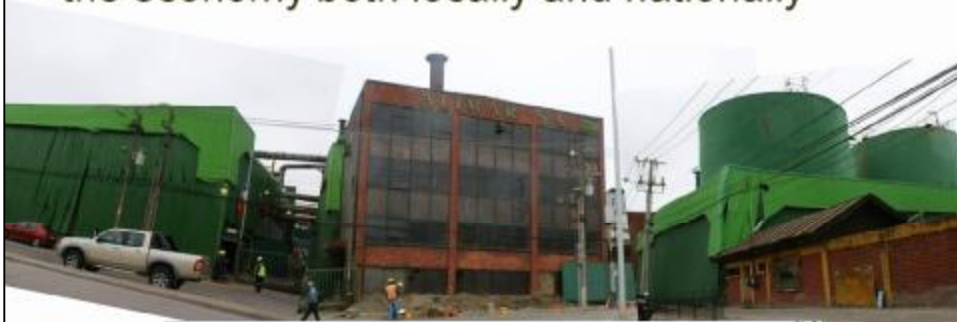
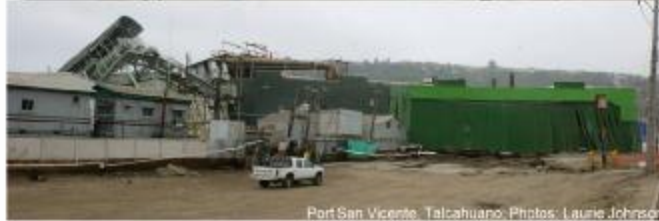
Port San Vicente, Talcahuano. Photos: Laurie Johnson

Fish processing plant closures are impacting the economy both locally and nationally

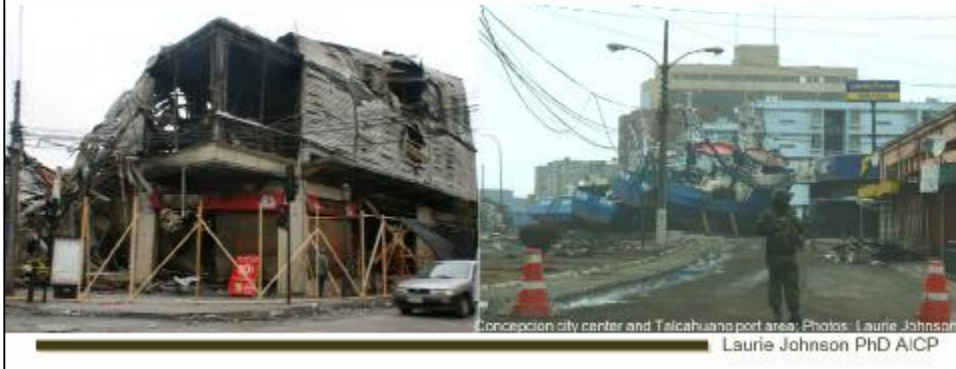
- Looting and civil unrest erupted throughout the central region, even in areas with relatively little damage
- Recovery has stalled in some places as residents want to stay safely away

Residents of remote coastal villages reported strangers coming in to loot.
